Foreshore and channel assessment of Monjerducking Gully

Report no. WRM 53
March 2009

Prepared by
BlueSands Environmental
for Department of Water

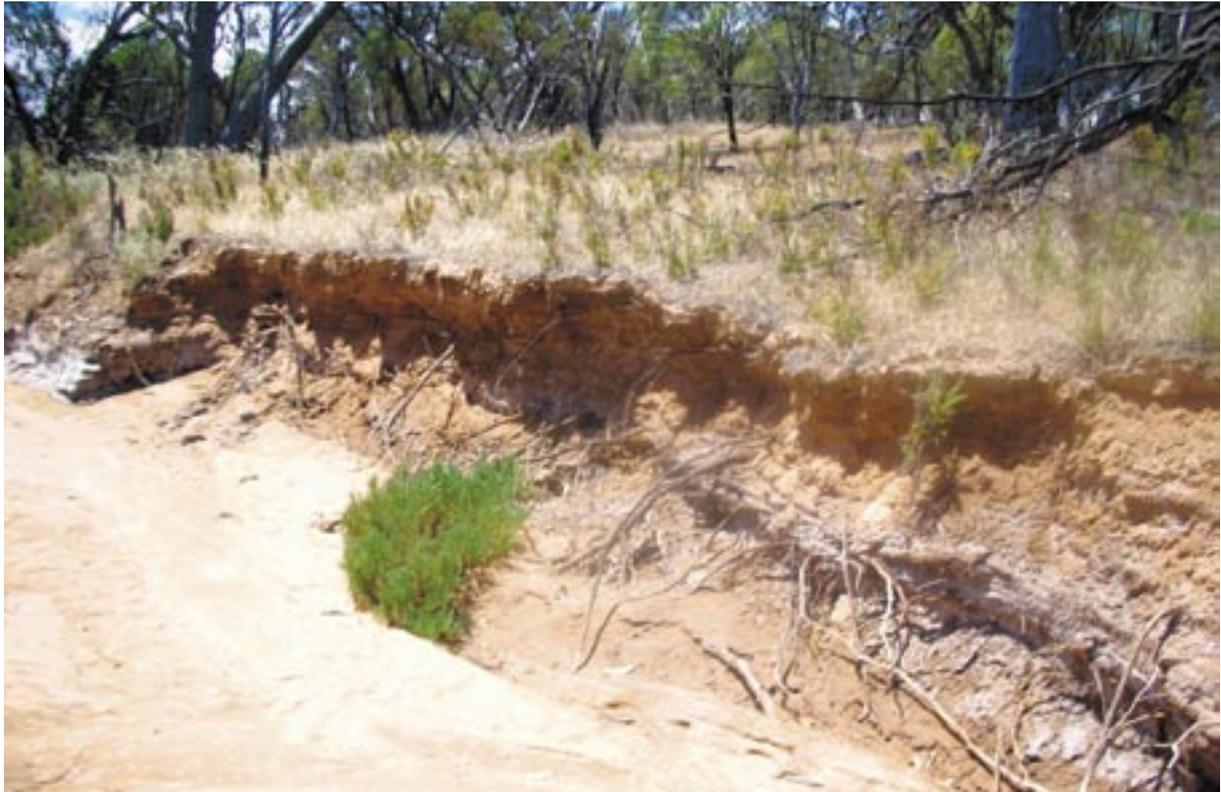
Photo 1 Bank undercutting on Monjerducking Gully

Undercutting occurs on vertical banks where an increase in flow velocity causes the channel to incise. The scouring action of the water against the banks causes mobilisation of sediment, resulting in the banks becoming undercut. Eventually the undercut bank, with no support from below, will collapse. This process is called slumping. Subsidence is another form of bank collapse where flows saturate banks and cause them to collapse under the added weight of the water (Pen, 1999).

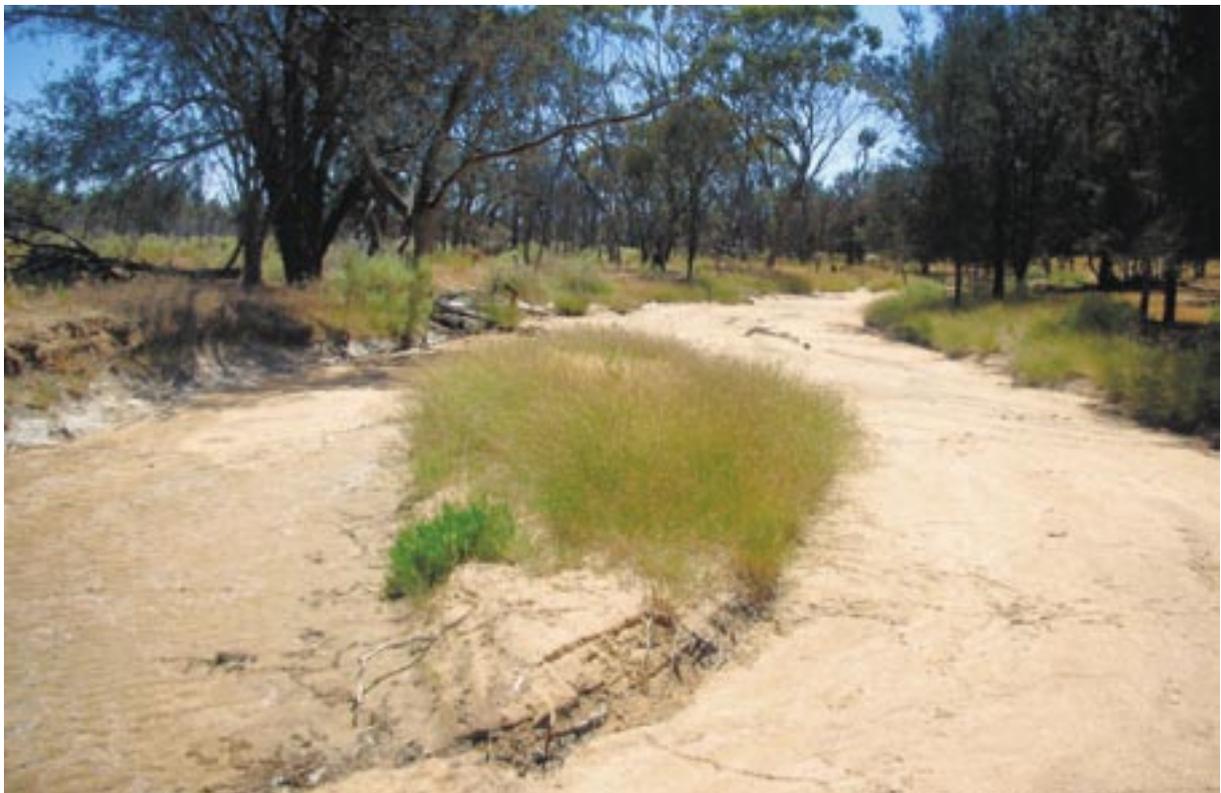
Photo 2 Sediment bar colonised by weeds in the braided channel of Monjerducking Gully

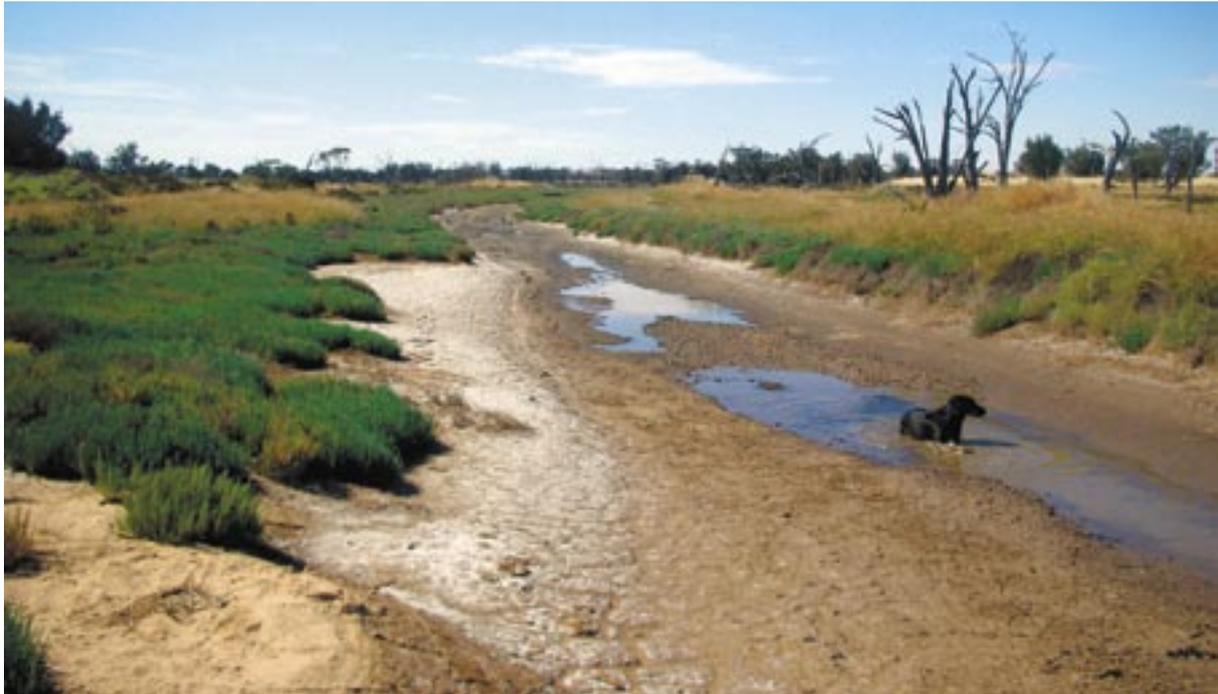
Photo 3 Stable banks well vegetated with samphire (Halosarcia sp.) on a downstream section of Monjerducking Gully

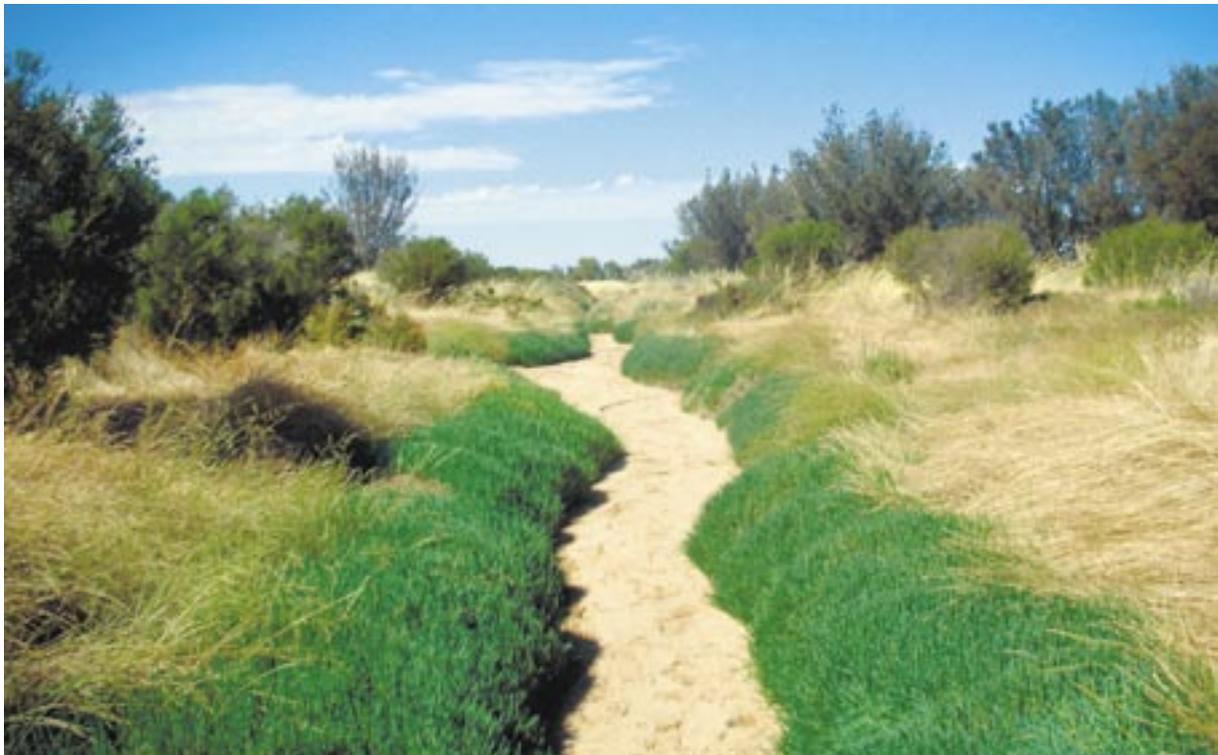
Photo 5 A B-grade reach of Monjerducking Gully (note the high occurrence of native species, including samphire (Halosarcia spp.) but also the dominance of weeds in the understorey)

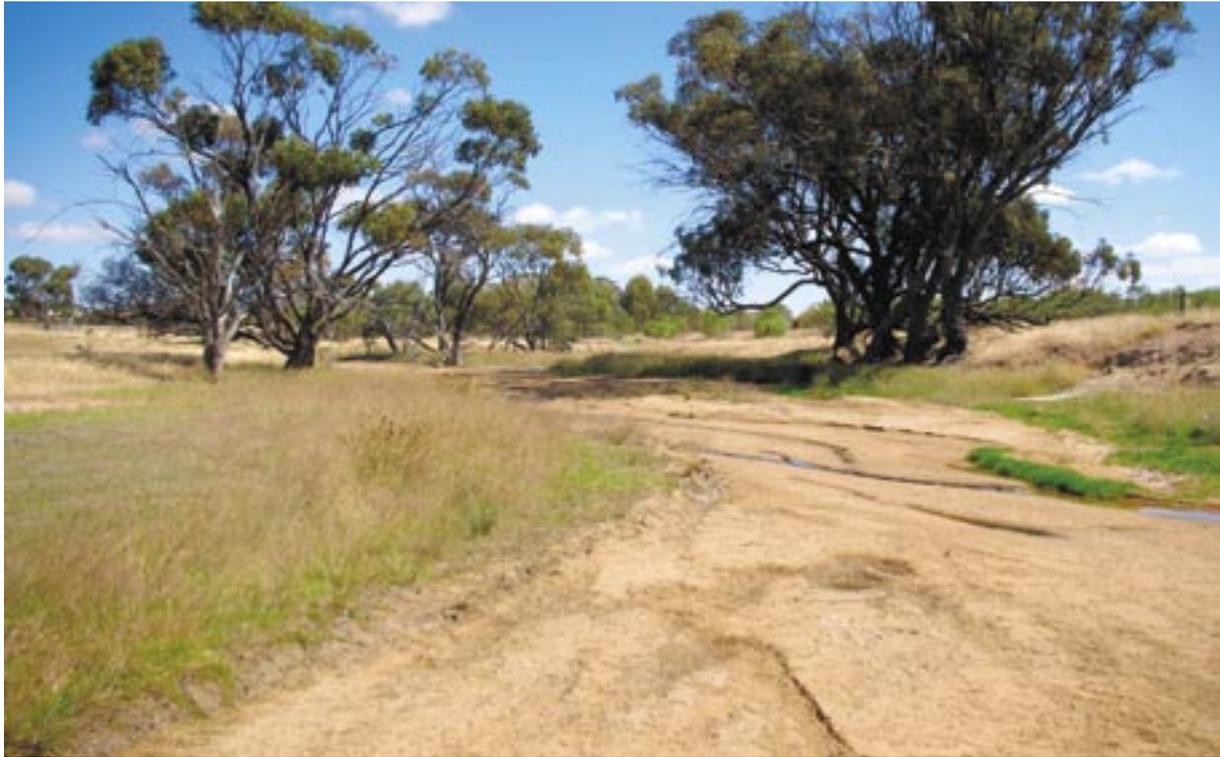
Photo 6 A C-grade reach of Monjerducking Gully (weeds dominate the understorey and the exposed banks are susceptible to erosion)

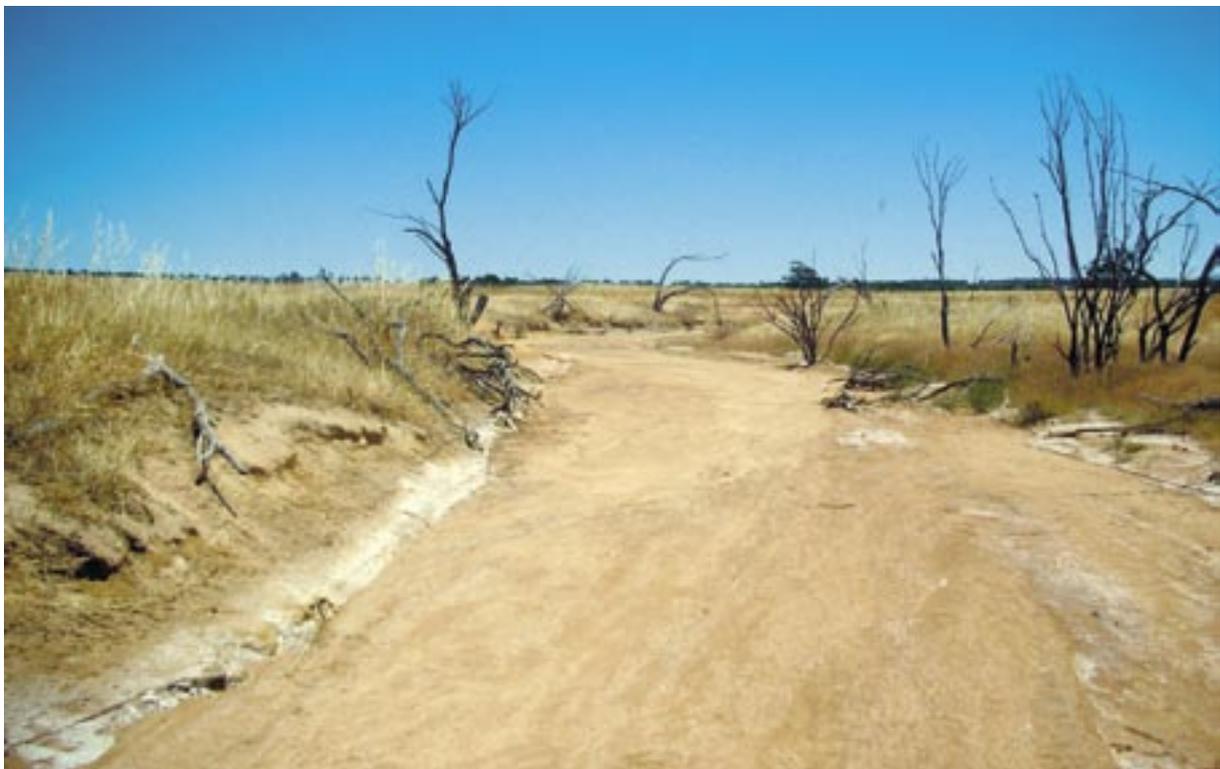
Photo 7 A D-grade reach of Monjerducking Gully (very little vegetation remains and the banks are heavily eroded)

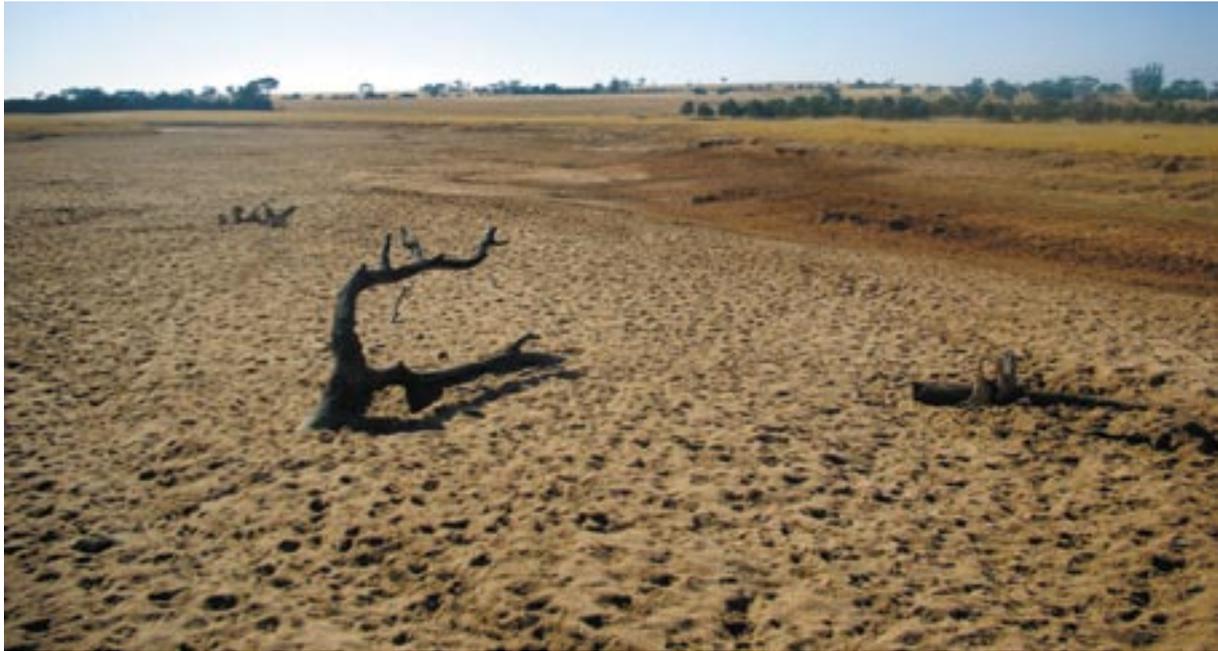
Undercutting, and to a lesser extent slumping, were the main forms of bank instability along Monjerducking Gully. Undercutting was evident in sections where there was little to no fringing vegetation and the banks were exposed to the erosive capacity of high, variable flows. Undercutting was localised in 64 per cent, significant in 20 per cent and severe in four per cent of sections in the main channel. Slumping was localised in 56 per cent and significant in 12 per cent of sections and occurred mainly where the banks had been undercut and eventually slumped into the channel, contributing more sediment to the channel.

Photo 8 The absence of fringing vegetation has resulted in severe lateral erosion in the middle reaches of Monjerducking Gully. Unrestricted stock access is also evident in this photograph.

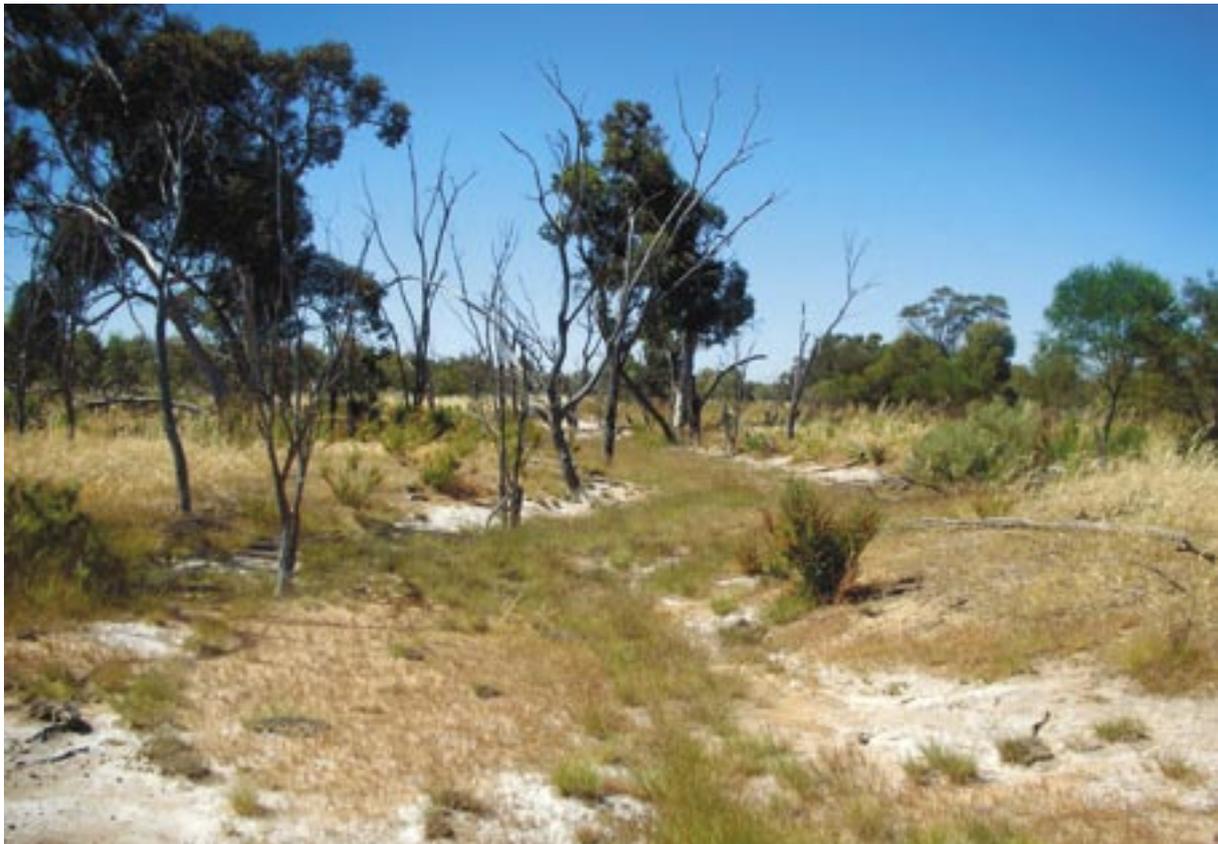
Anabranches occur in 24 per cent of sections, although they are more common in the middle reaches (Photo 9). Many of these anabranches are still connected to the main channel, although they would only receive water during high flow events.

Photo 9 An anabranch in the middle reach of Monjerducking Gully

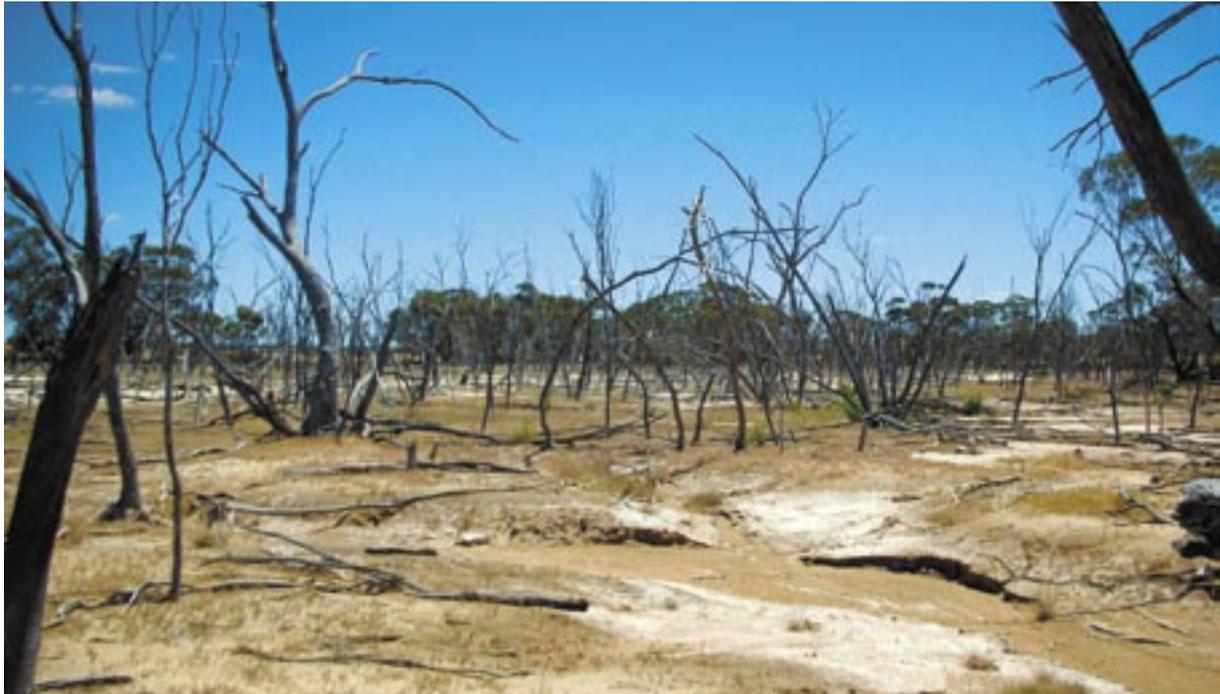
The vegetation appeared healthy in 20 per cent of sections in the main channel. In some sections the health of vegetation varied significantly, especially if that section contained a salt lake. In most instances, vegetation in and around the salt lakes was dead or in declining health (Photo 10) but vegetation away from the lakes tended to be healthy and was regenerating.

Photo 10 Dead trees were common in the salt lakes that are located in the Monjerducking Gully floodplain

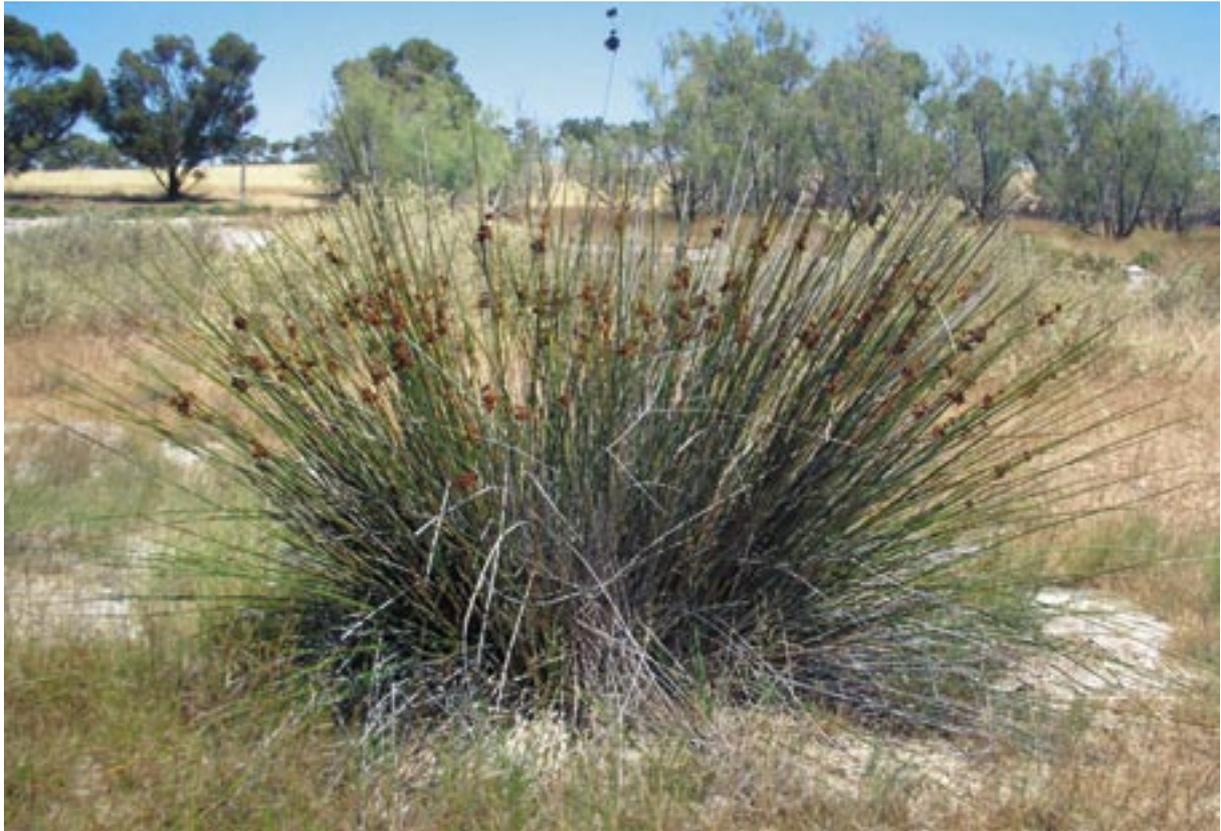
Photo 11 Sharp rush (Juncus acutus) in the floodway of Monjerducking Gully

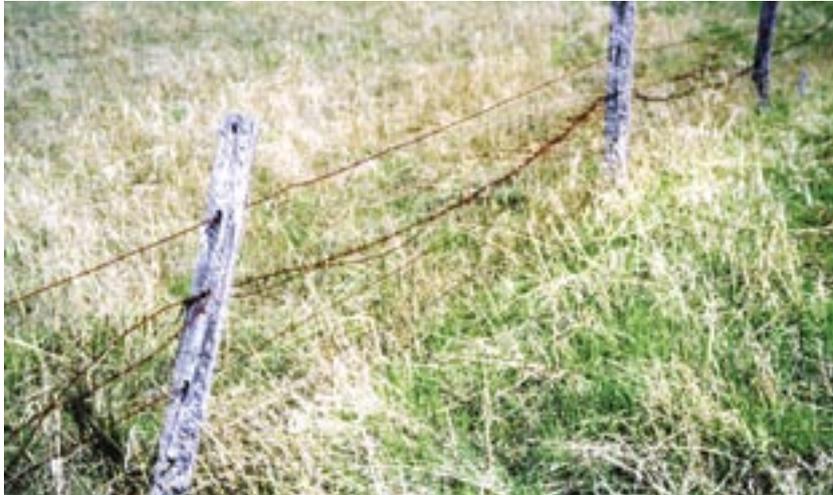
Fence in poor condition

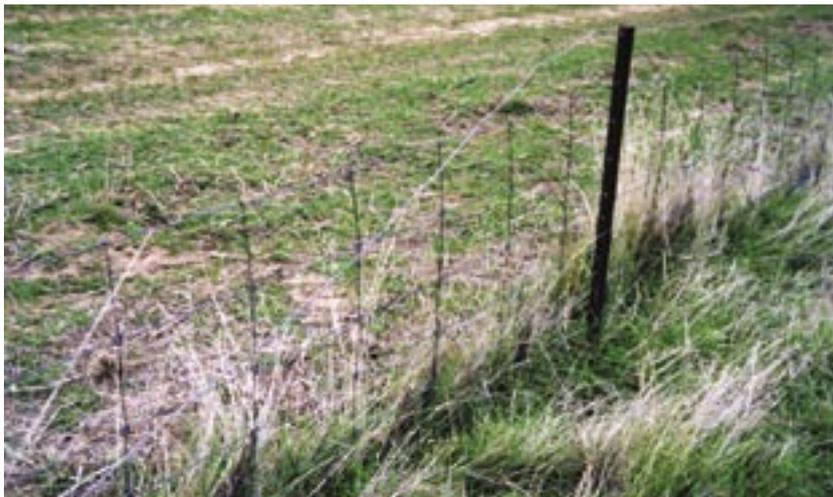
Fence in moderate condition
