Foreshore and channel assessment of Monjerducking Gully

Report no. WRM 53
March 2009

Prepared by
BlueSands Environmental
for Department of Water

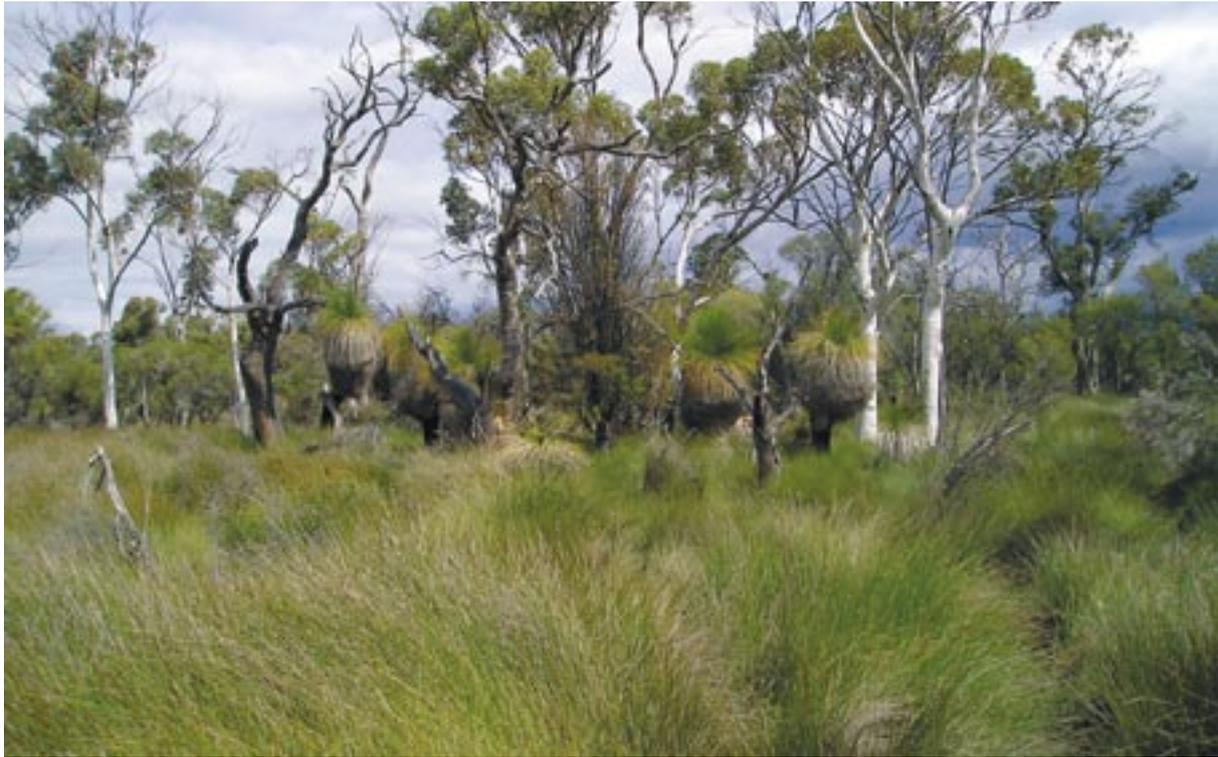
Photo 4 An A-grade reach of a tributary of Christopher Brook in the Dale River catchment (note the well vegetated channel along the right hand side and an absence of weeds)

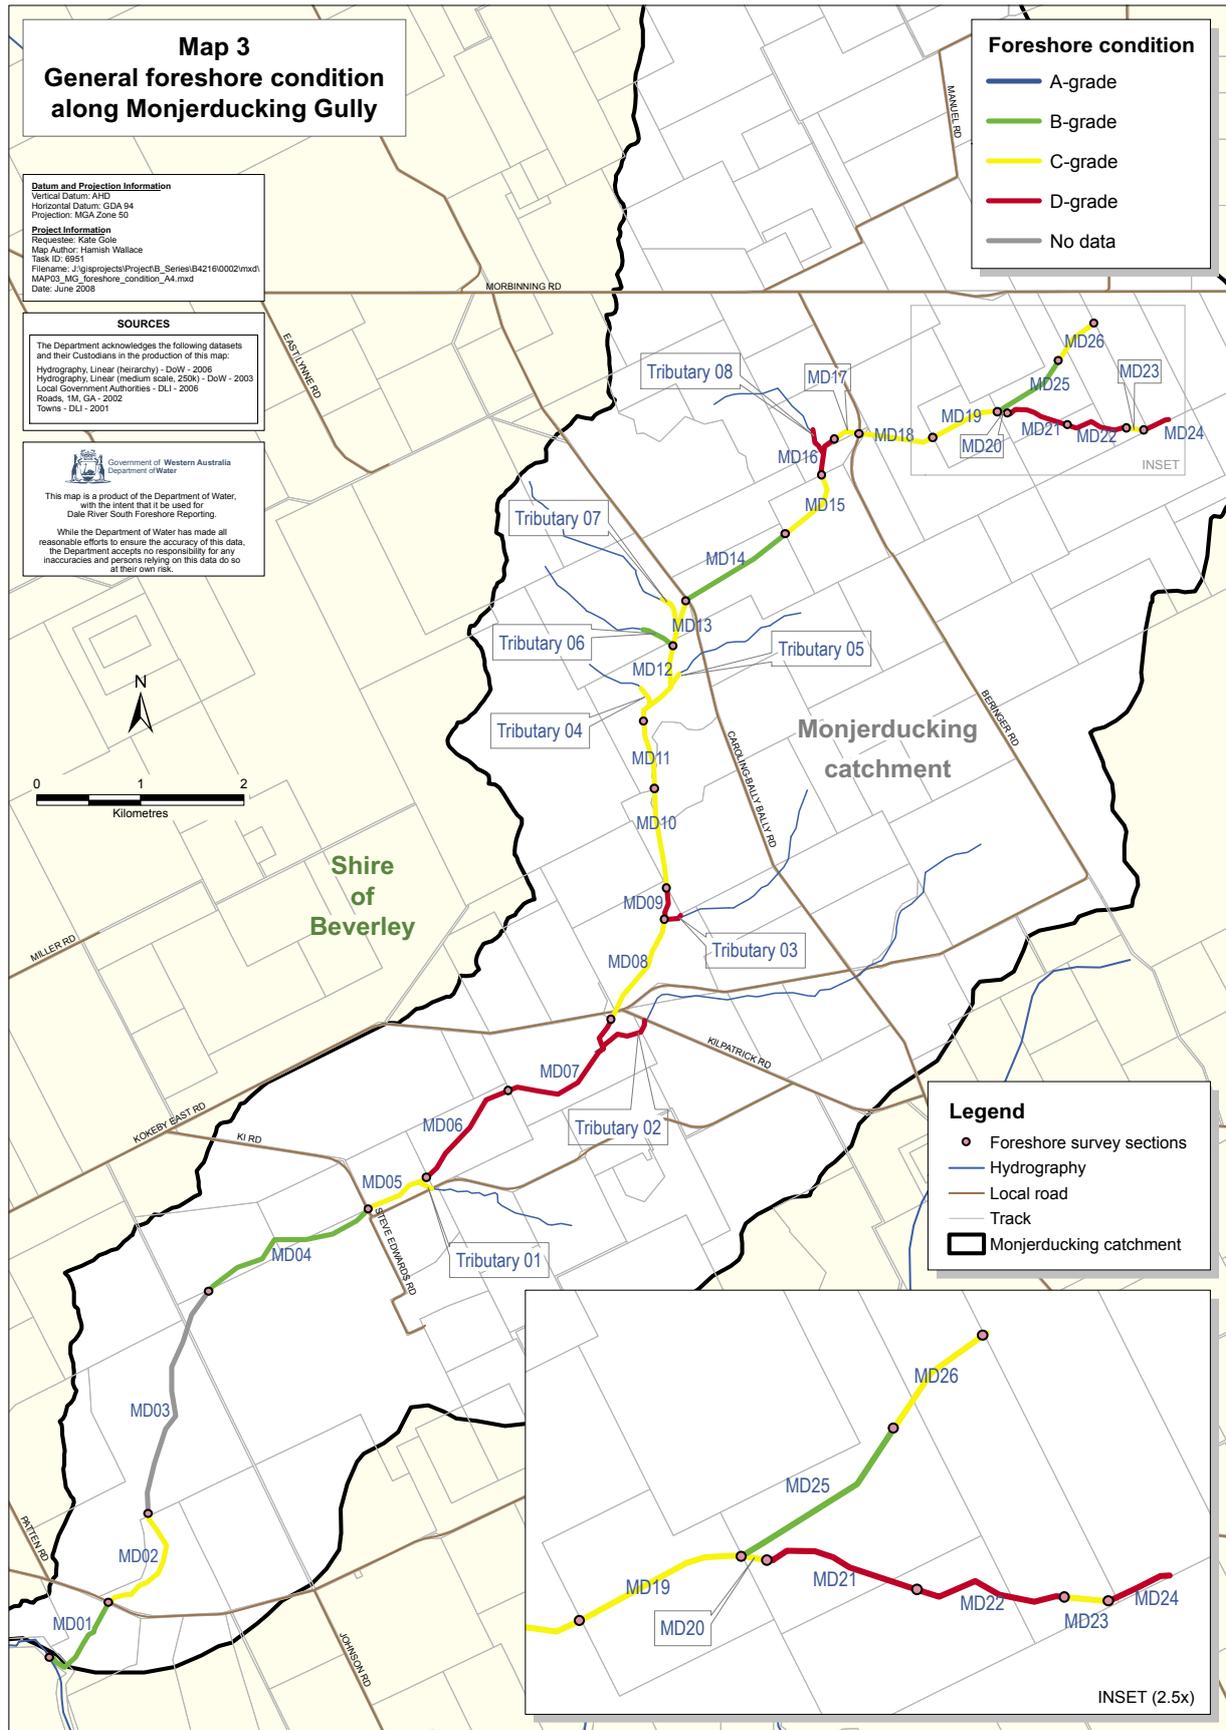
Along the main channel of Monjerducking Gully, there were no sections rated in excellent health (Map 4). There was one section (MD004) which was rated to be in good health (Table 14). This section has been fenced from stock for more than 20 years and as a result has healthy, regenerating fringing vegetation and a diversity of habitats. The fringing vegetation is effectively stabilising the banks in this section, resulting in only localised erosion points, such as on meander bends.

The majority of the main channel was assessed to be in poor environmental health, with 9.5km (45 per cent) of the waterway falling into this category. This was due primarily to the lack of healthy, dense fringing vegetation, the presence of weeds and a level of erosion which was further degrading the existing vegetation.

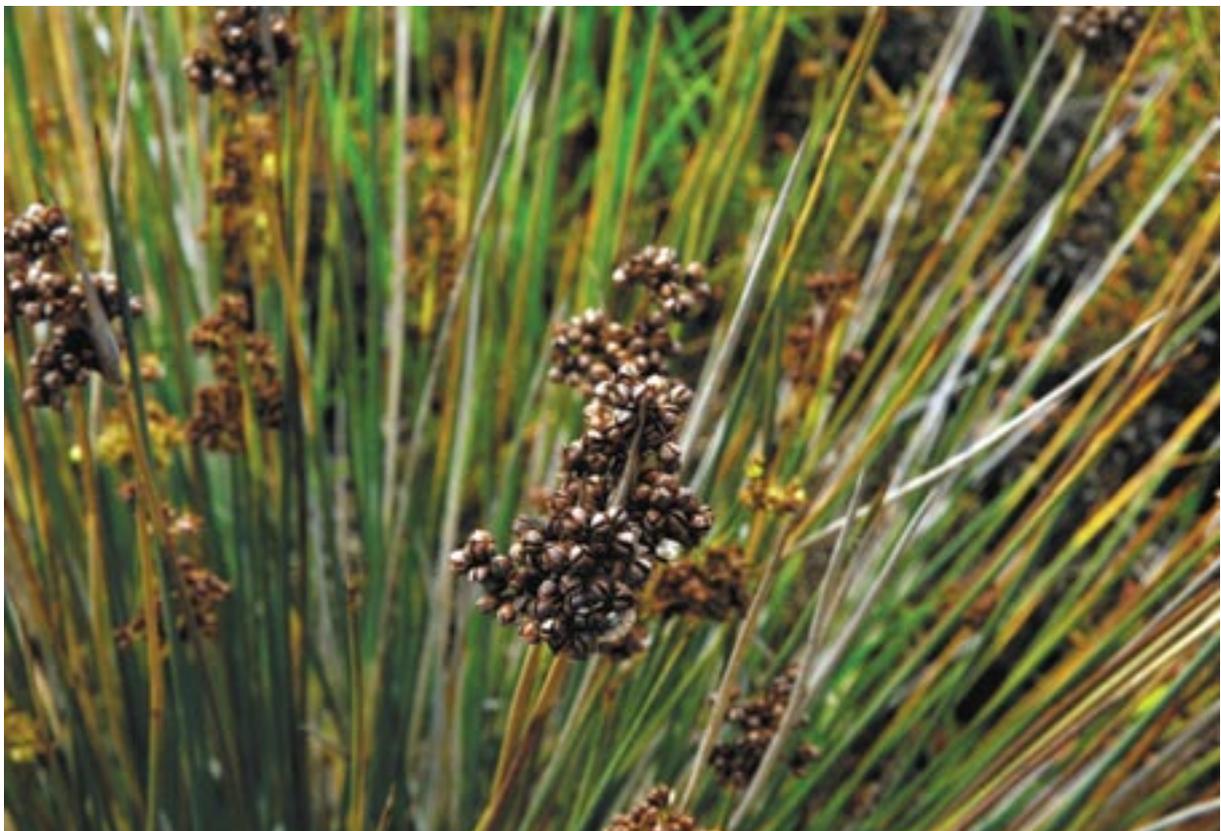
This species has been mistaken for a native rush by many landowners and as such, has been left untreated. Photos 11 and 12 illustrate the growth form and seed heads of sharp rush (*Juncus acutus*).

Photo 12 Sharp rush (Juncus acutus) seed head (Photo: Kate Gole, Department of Water)

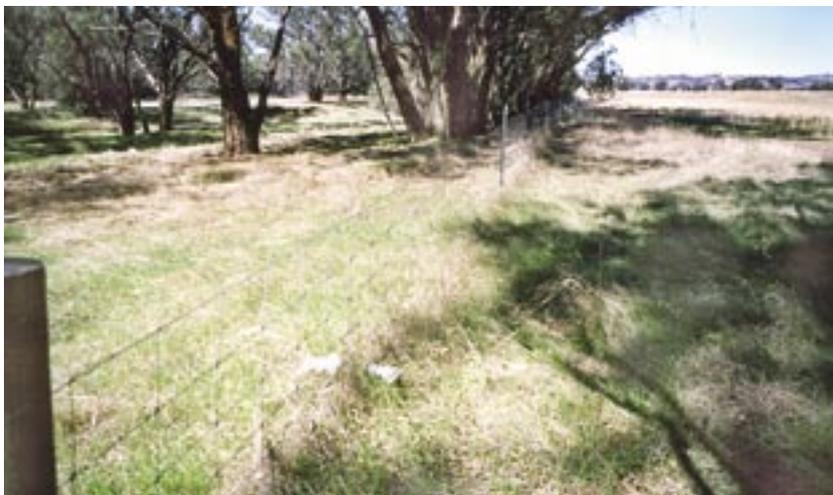
Fence in good condition
